Everest Printer Troubleshooting and Repair

Use this procedure to troubleshoot problems on an **Everest III** or **Everest 600™**.

Triage and Diagnose Everest Printer Problems

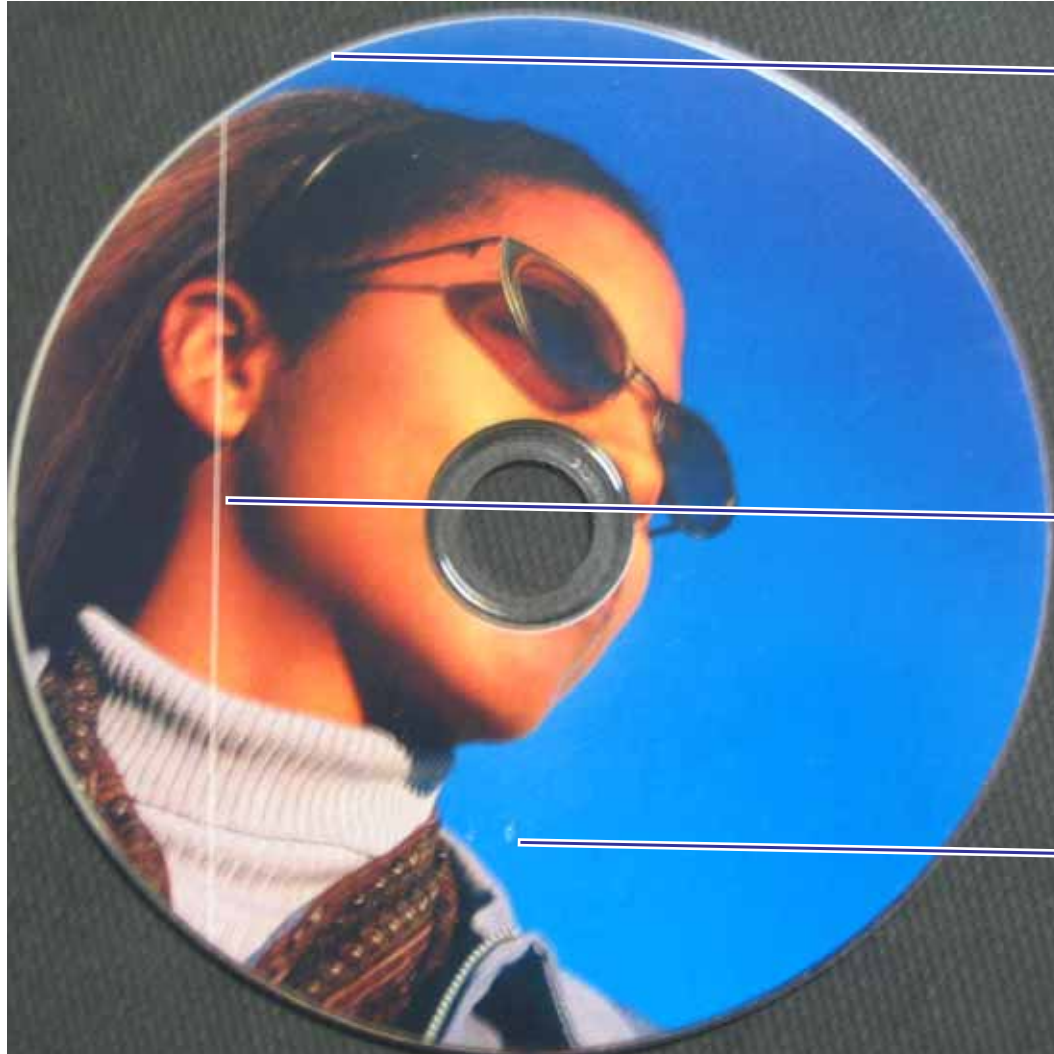
Damaged Print Head

Vertical line could be narrow or wide

Small Voids Caused by dirt in the printer

A vertical line running from top to bottom in the same location on every disk.

- Infrequent or improper cleaning and maintenance of the printer.
- Equipment placed in a dusty location or missing, damaged, or dirty fan filters.
- High number of prints on the printer.

Fix slightly shifted print in the print driver by adjusting the horizontal and vertical position

- Clean the print head, tacky rollers, platen roller, and guide rollers.
- Replace the print head bracket assembly.
- Check the print head cable connections and look for bent connector pins.

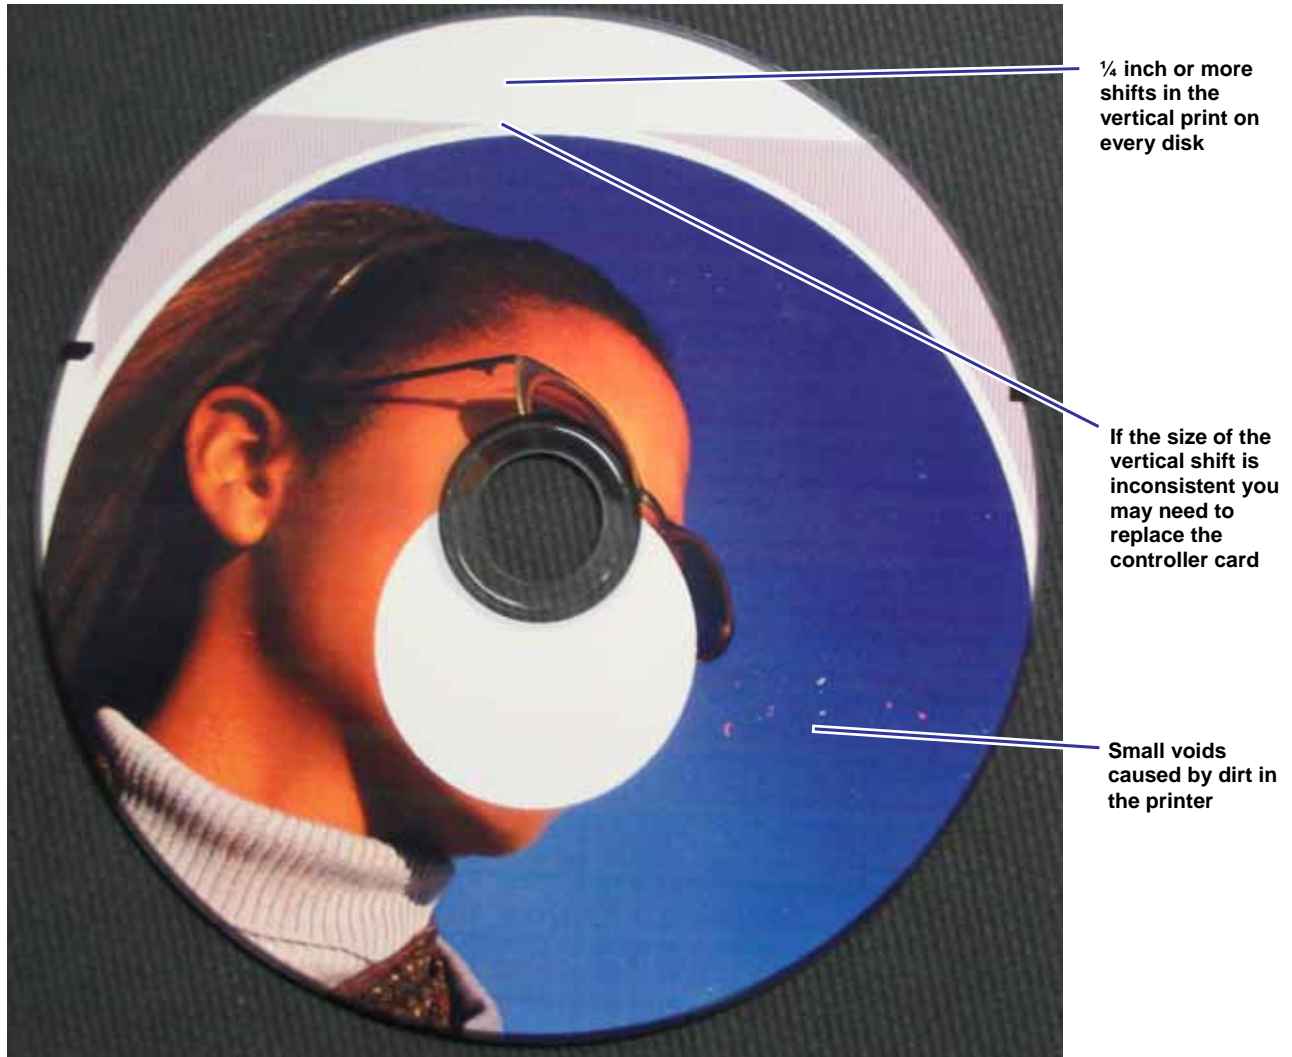
Lower Retransfer Sensor

A 1/4 inch (1cm) or more vertical shift in the position of the print on all discs. This shift is consistent and too large to fix using the vertical position adjustment.

- Internal Everest printer packing material was improperly installed when shipped.
- High number of prints on the printer.

- Remove and straighten the lower retransfer sensor mounting bracket.
- Replace the lower retransfer sensor and mounting bracket.
- Clean the lower RT sensor.

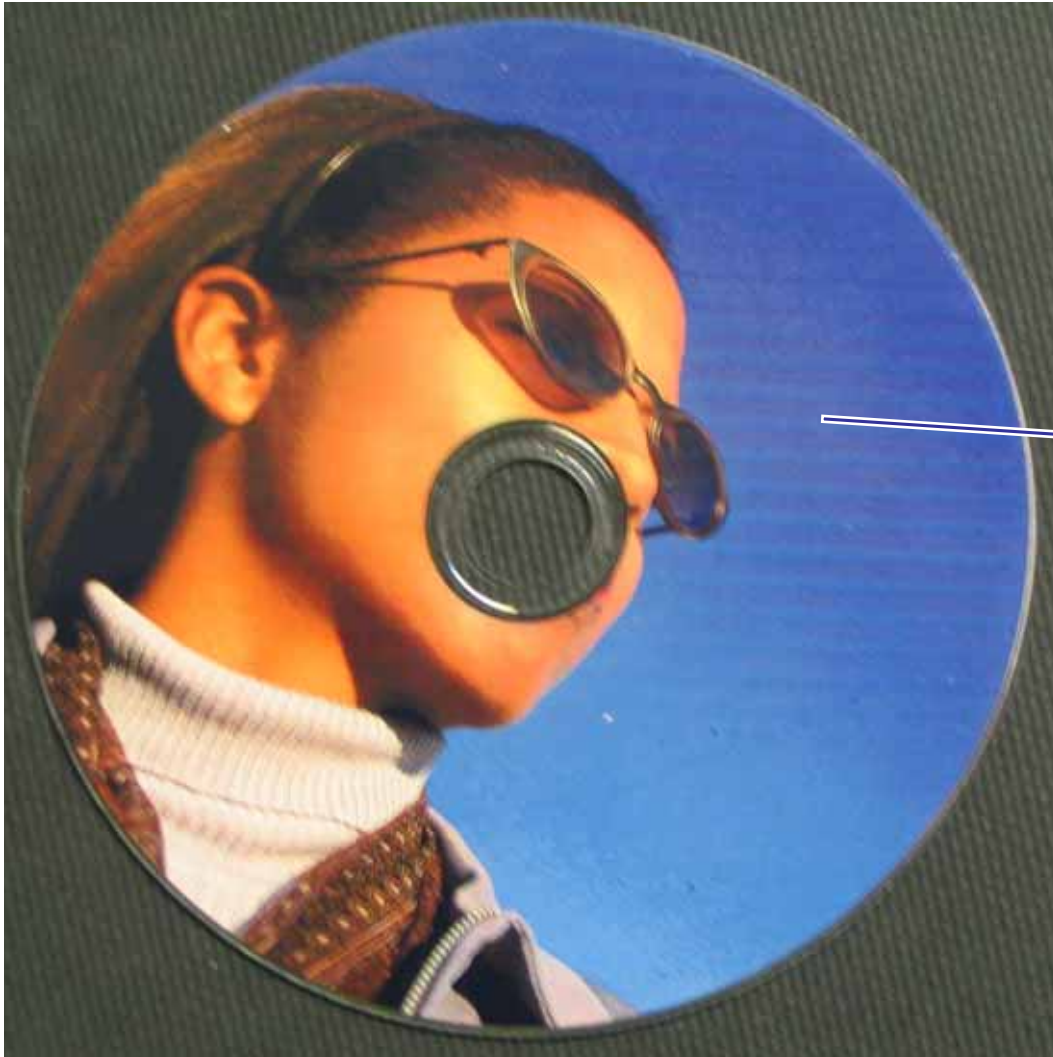
Ribbon Torque Limiter, 2500

Banding, this will be seen most clearly on solid colors

Narrow bands of different color that run horizontally across the print. The problem is most easily seen in a solid color and can vary in size and color.

- High number of prints on the printer.
- If less than 10k prints it could be a defective part.

- Replace the ribbon torque limiter (2500).

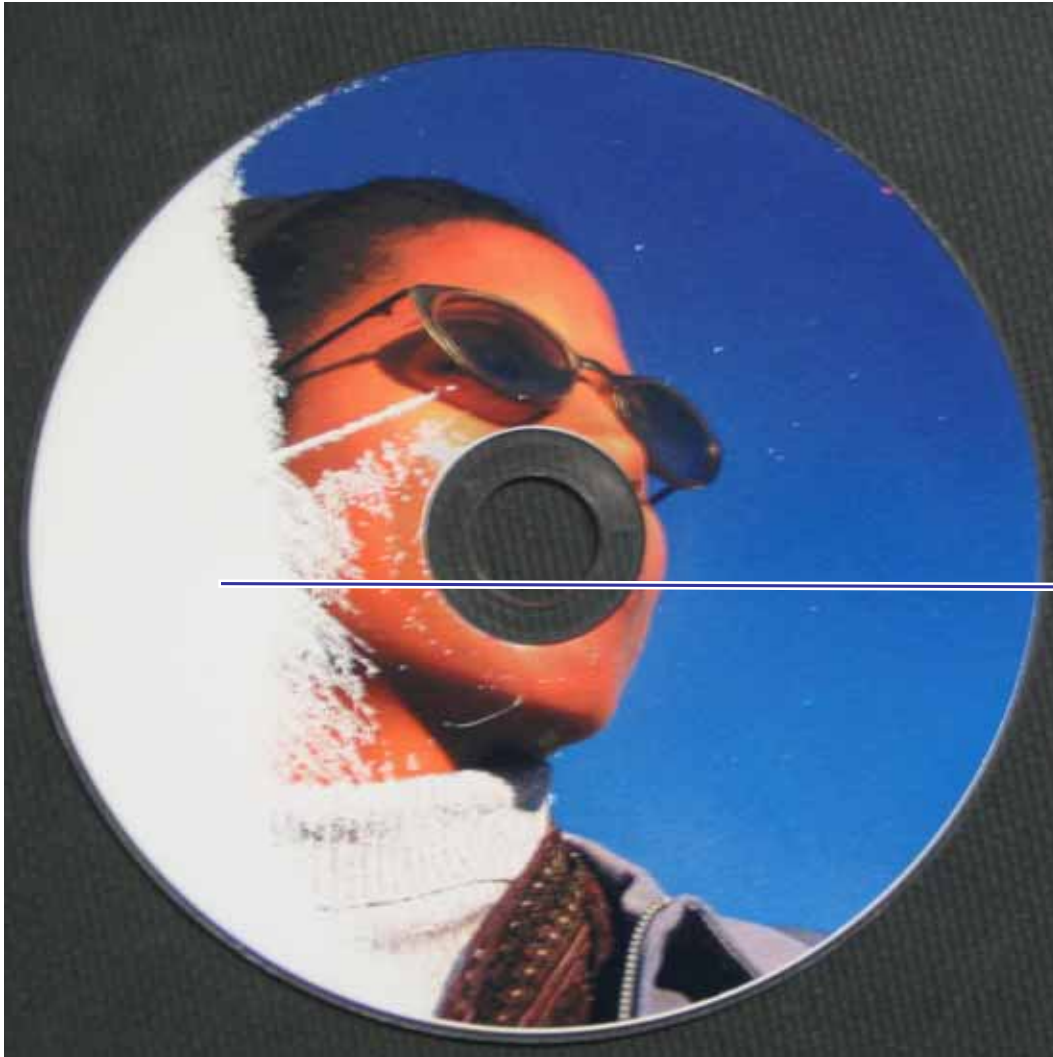
Heat Roller

Narrow to wide vertical voids in the print on one side of the disk.

A vertical void in the print that starts from one edge of the disk and extends inward $\frac{1}{4}$ inch to over an inch. If you look at the retransfer sheet the color will still be there. If the color is not there look at head alignment and platen problems.

- High number of prints on the printer.
- Infrequent or improper cleaning and maintenance of the printer.
- Printer frame bent so that heat roller is out of alignment, printer dropped or damaged.

- Inspect and clean the platen roller, replace if damaged.
- Check the heat roller for damage, loose screws, and broken springs, repair or replace as needed.
- Make sure the heat roller runs in the printer tray guides and that they are clean.

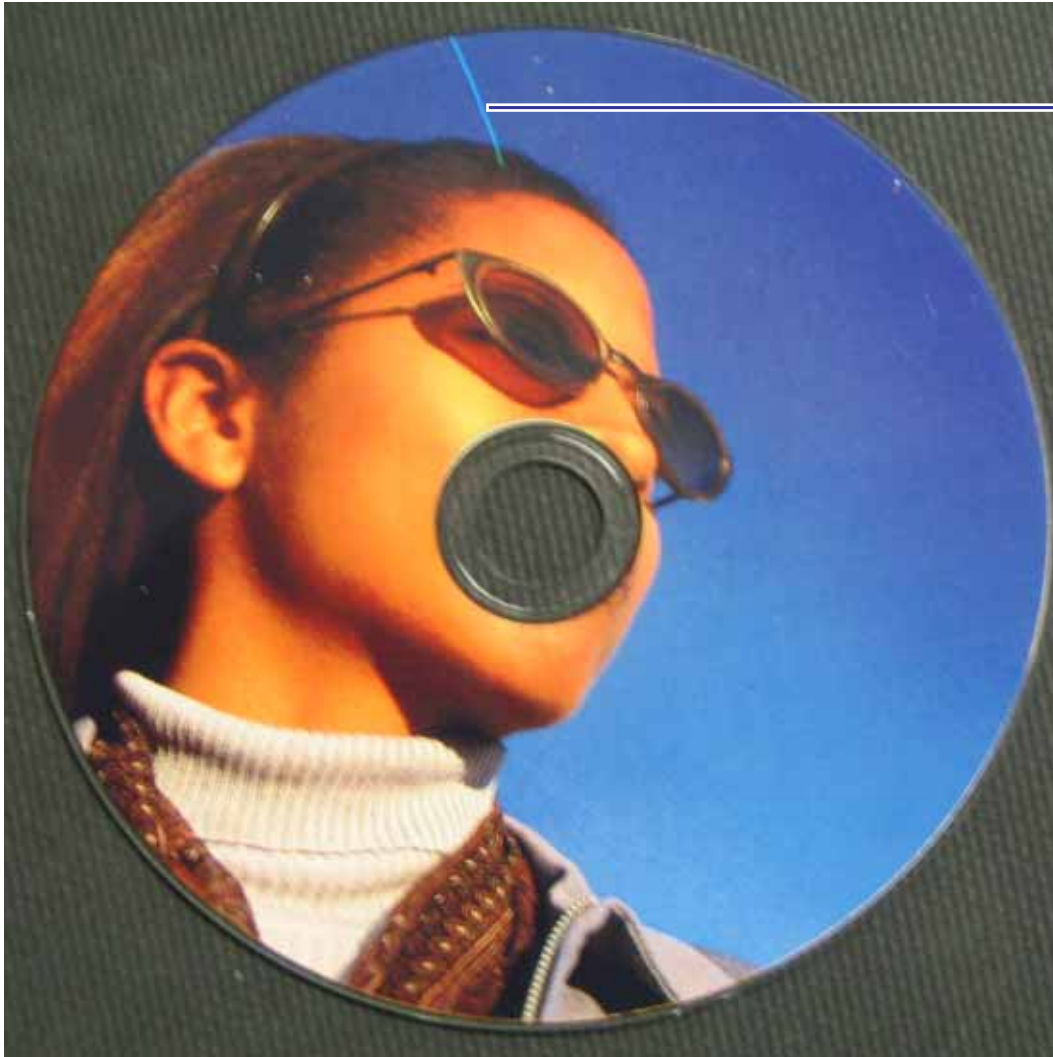
Print Head Alignment

Small curved void(s) in the print could be one or more color

Small curved void(s) in the print at the top or side of the disk and could be in one or more of the color panels.

- High number of prints on the printer.
- Infrequent or improper cleaning and maintenance of the printer.
- Rough handling of the ribbon carriage during installation and removal.

- Inspect the ribbon carriage for damage, tighten screws, and make sure it sits squarely in the printer.
- Make sure the print head mount shaft is tight on both ends, that the mounting screws are tight, and that the head assembly is properly aligned.
- Clean the print head, tacky rollers, platen roller and guide rollers.

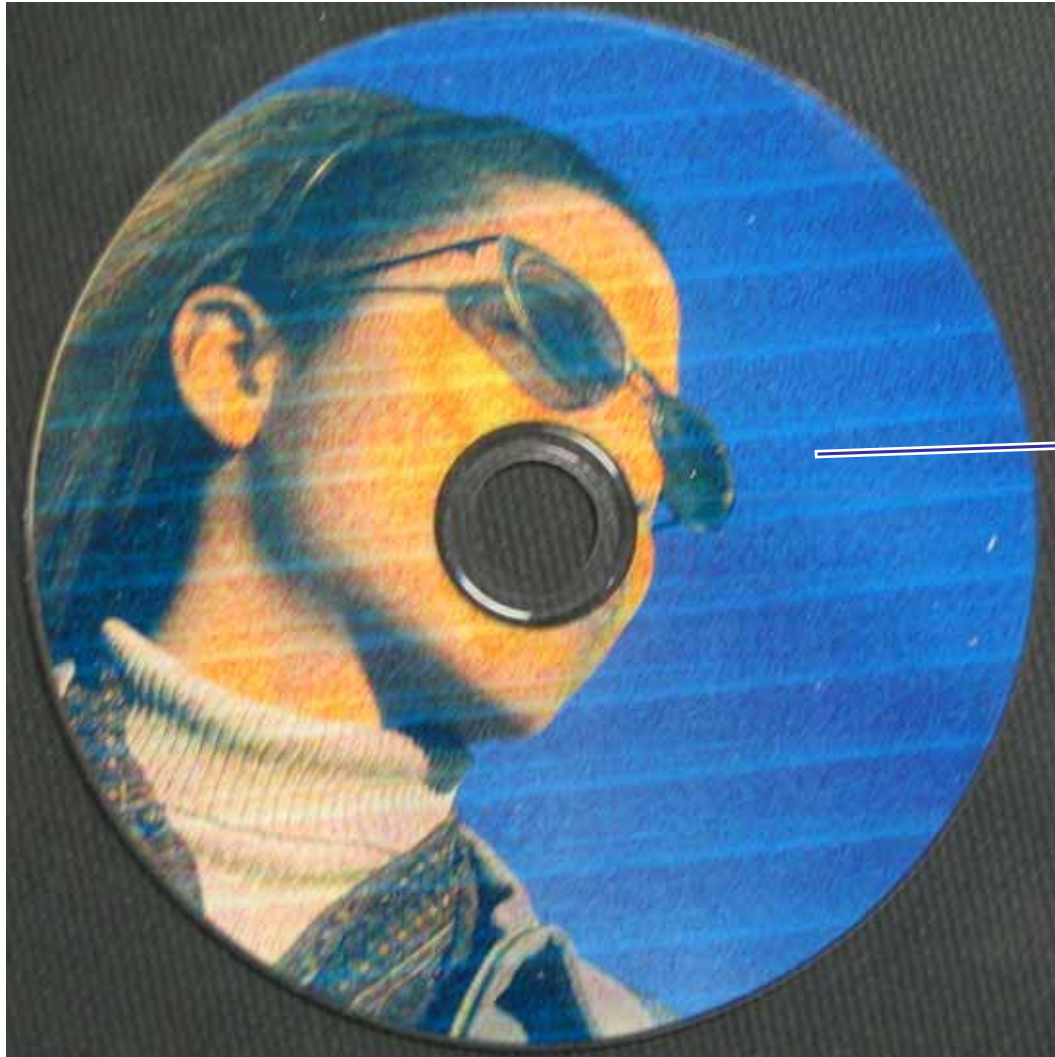
Controller Card

Faded color,
lines and
static in the
print over the
entire disc

The print looks faded and there are lines of off color and pixilation over the face of the entire disc.

- High number of prints on the printer.
- Static discharge into the printer.
- Part failure.

- Make sure all cable connections going to the controller card and the print head are properly seated.
- Replace the controller card.
- Replace the print head bracket assembly.

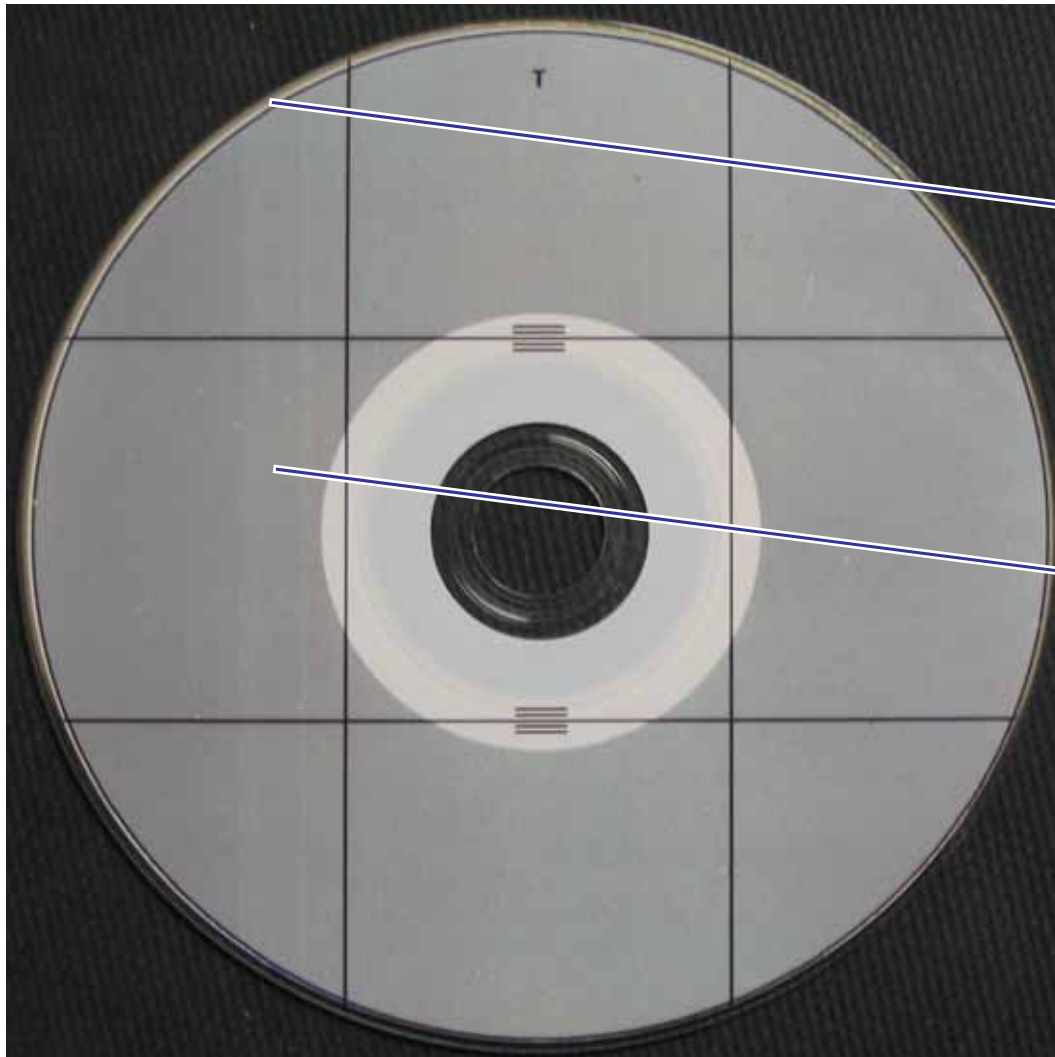
Print Head, Platen Roller

Off color lines in the print that can be horizontal or vertical.

Off color lines in the print that can run horizontal or vertical and extend all or part of the way across the disc.

- High number of prints on the printer.
- Static discharge into the printer.
- Infrequent or improper cleaning and maintenance of the printer.

Fix slightly shifted print in the print driver by adjusting the horizontal and vertical position

- Clean the print head, tacky rollers, platen roller, and guide rollers.
- Inspect and clean the platen roller, replace if damaged.
- Replace the print head bracket assembly.

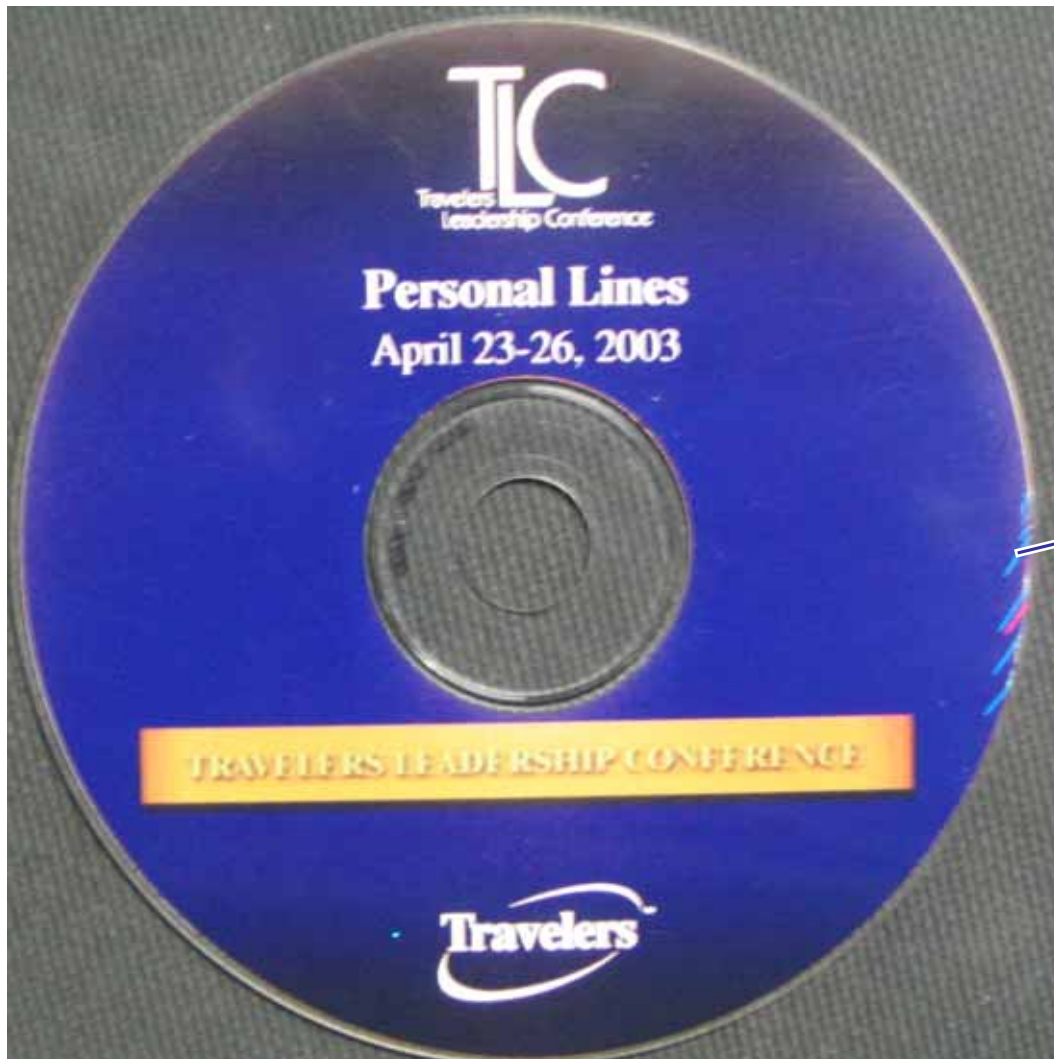
Print Head Alignment, Platen Roller

Small lines or voids in one or more of the ribbon colors

Small to medium lines or voids in the print that effect one or more of the ribbon colors. The lines can be on the left or right side and angle up or down.

- High number of prints on the printer.
- Infrequent or improper cleaning and maintenance of the printer.

- Inspect the ribbon carriage for damage, tighten screws, and make sure it sits squarely in the printer.
- Make sure the print head mount shaft is tight on both ends, that the mounting screws are tight, and that the head assembly is properly aligned.
- Inspect and clean the platen roller, replace if damaged.
- Replace the print head bracket assembly.

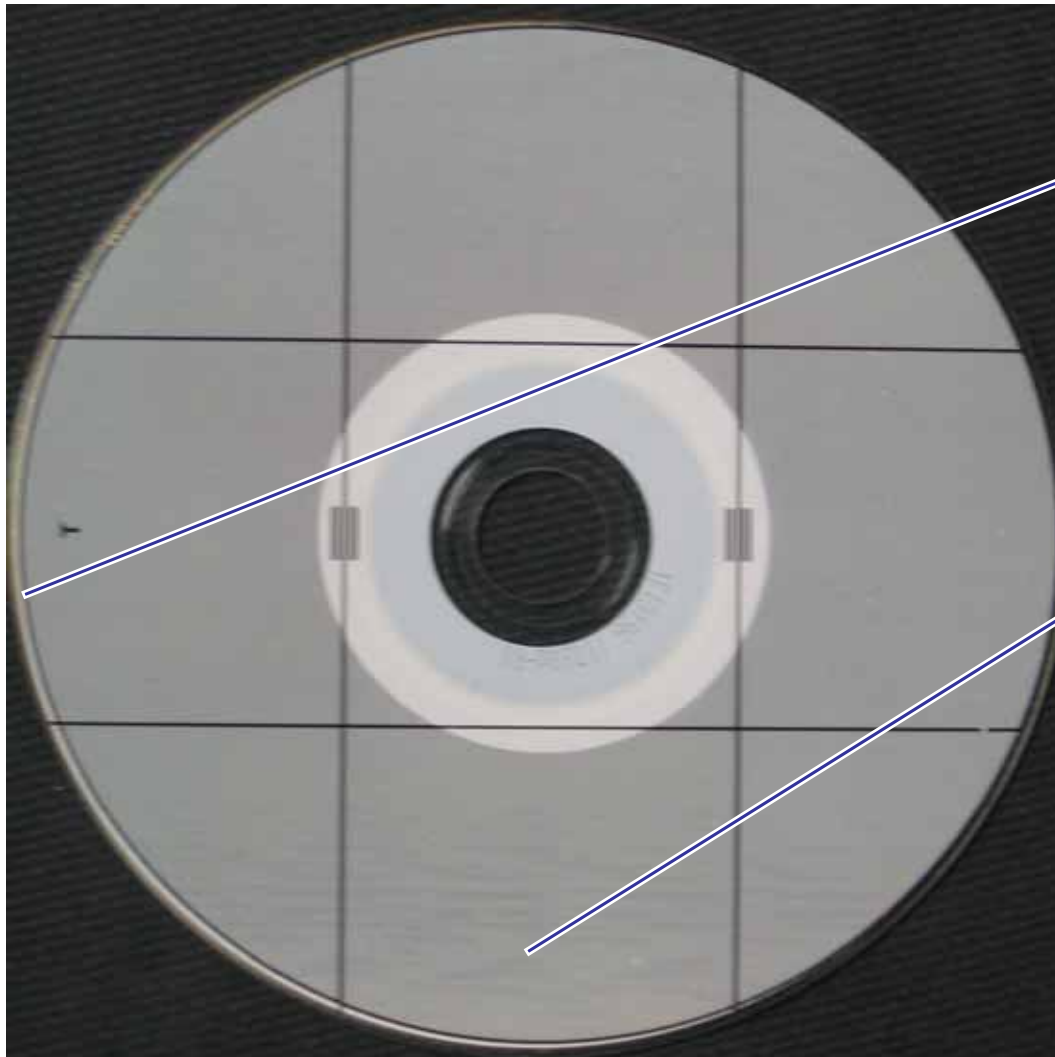
Print Head, Platen Roller, Upper RT Sensor

Small to large area of the disc where the print looks like its melting

A small to large area of the disc usually at the top or bottom where the color varies giving the print a “melting” or “scaly” look.

- High number of prints on the printer.
- Dirty head guide roller.
- Infrequent or improper cleaning and maintenance of the printer.

Fix slightly shifted print in the print driver by adjusting the horizontal and vertical position

- Clean the print head, tacky rollers, platen roller and guide rollers. Pay very close attention to the guide rollers on the head assembly.
- Make sure the print head mount shaft is tight on both ends, that the mounting screws are tight and that the head assembly is properly aligned.
- Inspect and clean the platen roller, replace if damaged.
- Replace the print head bracket assembly.

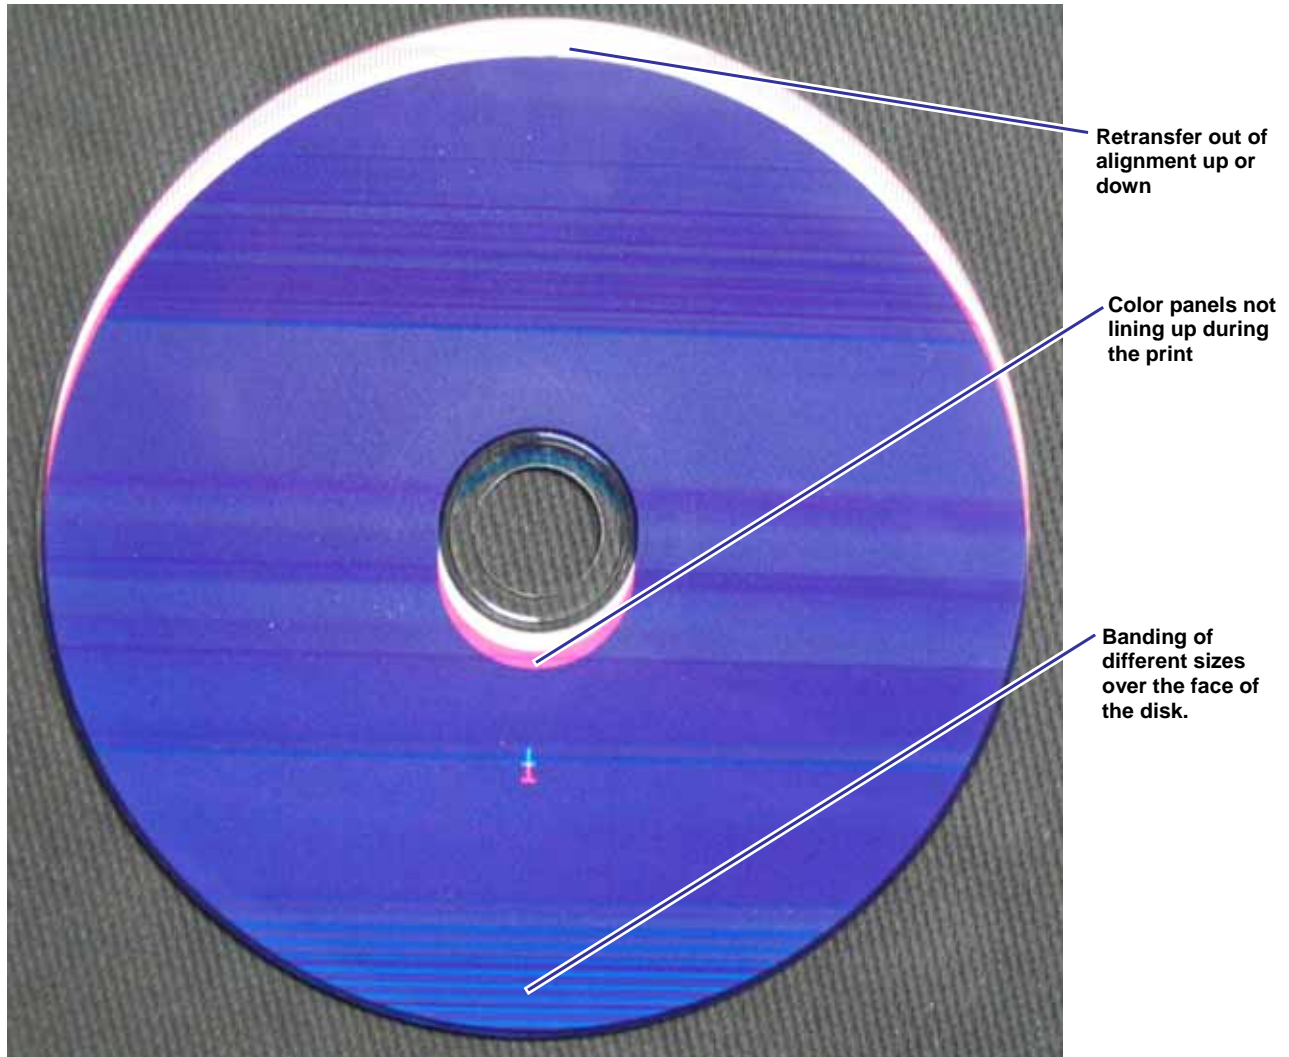
Platen Roller, Ribbon Sensor

The retransfer has shifted but it is not the same on each disc. There is banding over the full surface. The color panels don't line up.

- High number of prints on the printer.

- Check to make sure that the platen roller pulley and mounting screws are tight.
- Make sure that the ribbon sensor is undamaged, clean, and the screws are tight.
- Inspect and clean the platen roller, replace if damaged.

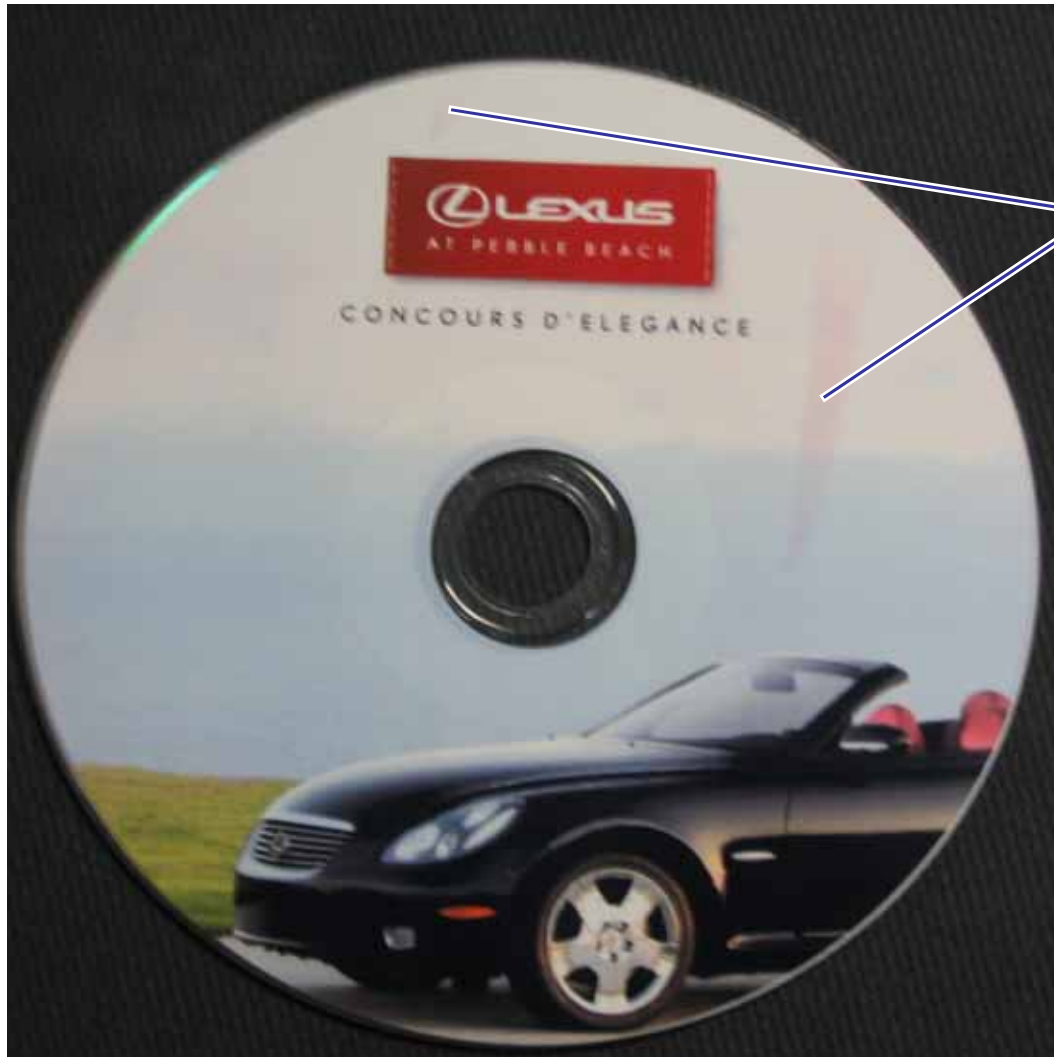
Ribbon Carriage

An area of shading or the wrong color embedded in the print

A large or small area, usually starting at the edge of the disk and narrowing to a point. The area will look like a shadow or is the wrong color.

- High number of prints on the printer.
- Rough handling of the ribbon carriage during installation and removal.

- Inspect the ribbon carriage for damage, tighten screws, and make sure it sits squarely in the printer.
- Make sure the print head mount shaft is tight on both ends, that the mounting screws are tight and that the head assembly is properly aligned.
- Inspect and clean the platen roller, replace if damaged.
- Clean the print head, tacky rollers, platen roller, and guide rollers.

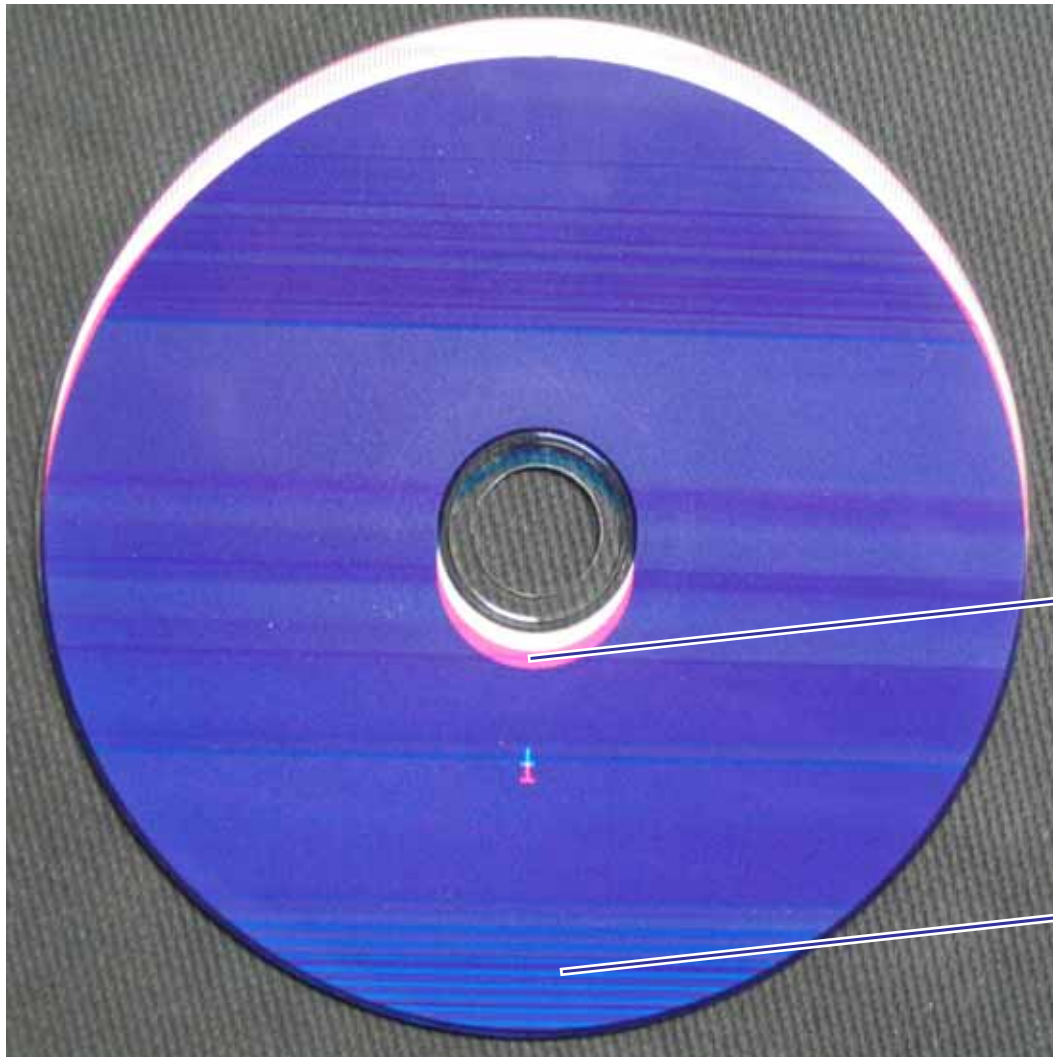
Ribbon Sensor, Controller Card, Upper RT Sensor

Color panels not lining up during the print

Banding of different sizes over the face of the disc.

There is banding over the full surface of the disc. The color panels don't line up. The retransfer may or may not line up.

- High number of prints on the printer.
- Internal Everest printer packing material was improperly installed when shipped.

- Make sure that the ribbon sensor is undamaged, clean, and the screws are tight, replace if needed.
- Make sure the Everest printer has the latest firmware.
- Make sure all connections to the controller card are secure. Replace the controller card if needed.

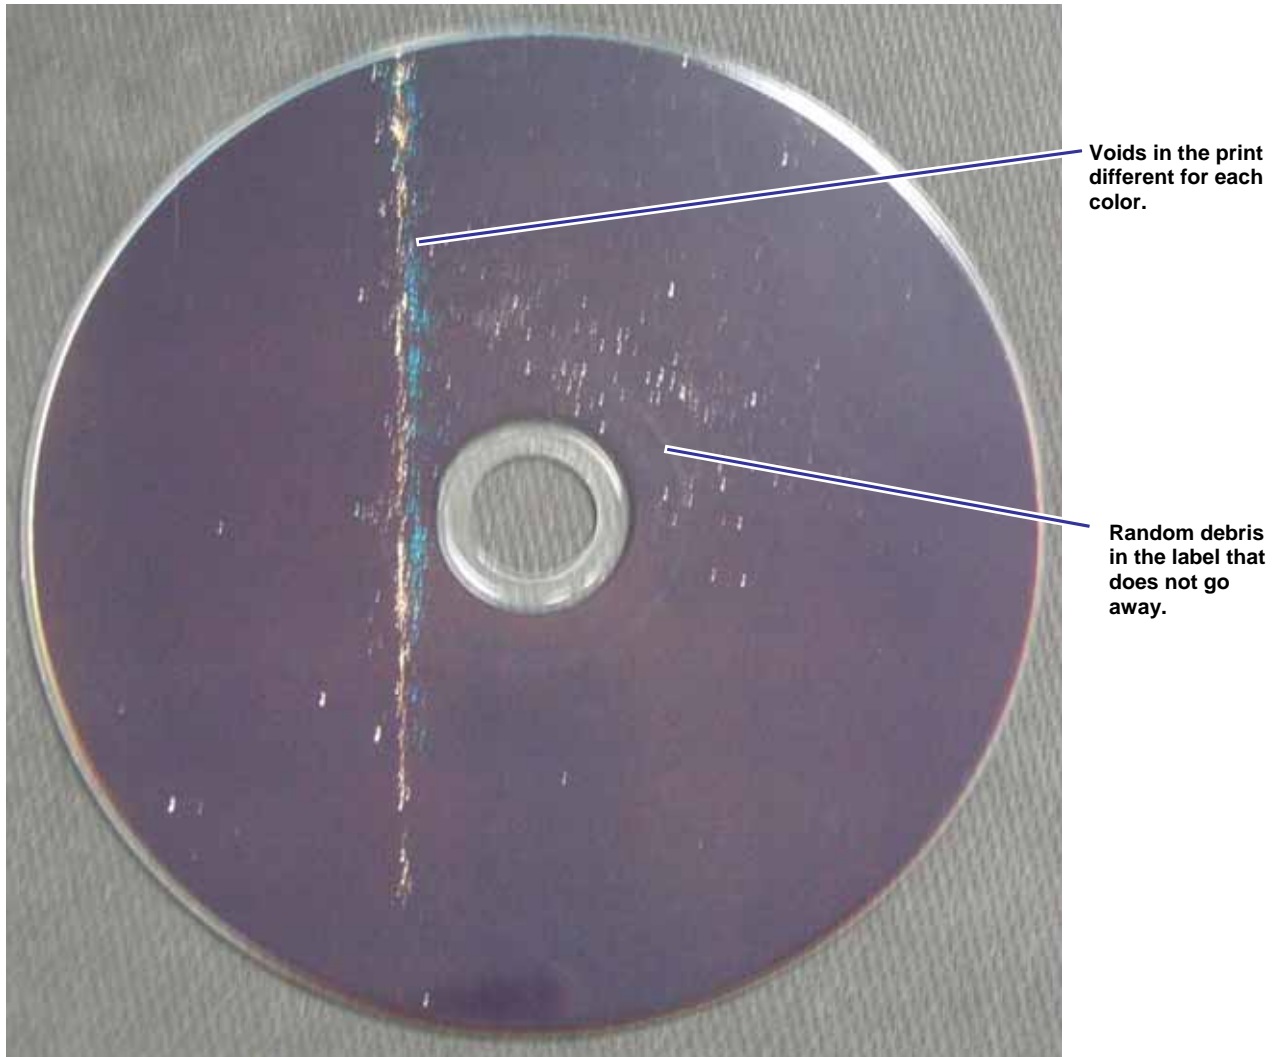
Tension Roller 2, Shaft 3

A line of debris in the label the goes most or part of the way down the disc. The voids change with each color and there is a large amount of debris on the label that does not go away.

- High number of prints on the printer.

- Check the ITS guide roller 2 and ITS roller shaft 3 for damage. Make sure the screws are tight and the bushings are not damaged.
- Clean the print head, tacky rollers, platen roller and guide rollers.
- Inspect and clean the platen roller, replace if damaged.
